Manhole Inspection Summary

Manhole # S17K__039MH

Location Address: **150 willard-alley-catherine**

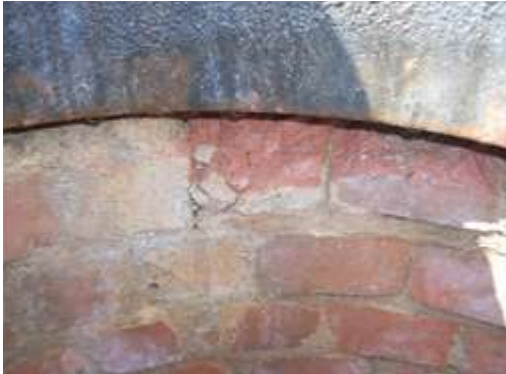
Defect 2

Condition: ☐ Sound ☐ Cracked ☐ Root Intrusion ☐ Loose Brick ☒ **Deteriorated**

deterioration of the corbel

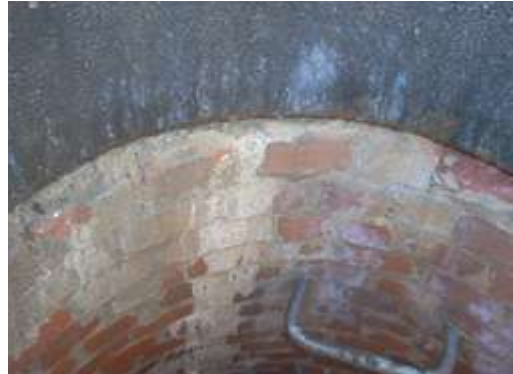
Defect 1

Infiltration: ☐ None ☒ **Joint** ☐ Cracks ☐ Mortar ☐ Roots ☐ Wall

infiltration of the corbel joint

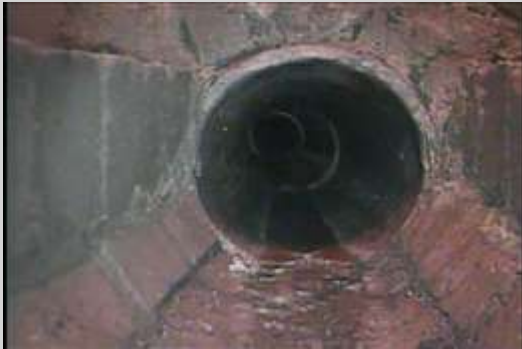
12 O'Clock Outflow

8 in. Circular Gravity Sewer
Pipe Out @ 12 O'Clock

Pipe Height: **8.4** (in.) Rod and Bar (Angled)
Pipe Material: **Clay** ☐ Pipe Lined
Invert Depth: **8.60** (ft.) Flow Characteristics: **Slow**
Deposits: ☒ None ☐ Mud ☐ Sludge ☐ Debris ☐ Grease
Silt Depth: **0** (in.) Deposits Extent:
Infiltration: **None** Pipe Seal Cond: **Sound**

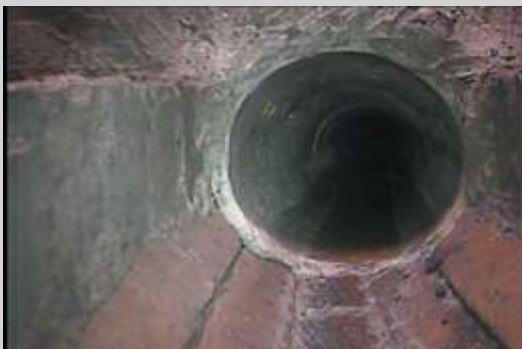
6 O'Clock Inflow

8 in. Circular Gravity Sewer
Pipe In @ 6 O'Clock

Pipe Height: **8.4** (in.) Rod and Bar (Angled)
Pipe Material: **Clay** ☐ Pipe Lined
Invert Depth: **8.44** (ft.) Flow Characteristics: **Slow**
Deposits: ☒ None ☐ Mud ☐ Sludge ☐ Debris ☐ Grease
Silt Depth: **0** (in.) Deposits Extent:
Infiltration: **None** Pipe Seal Cond: **Broken**
